Manhole Inspection Summary

Manhole # S55K__006MH

Insp Date: **9/9/09 10:42 AM**

Location Address: **800 S.Dean St.**

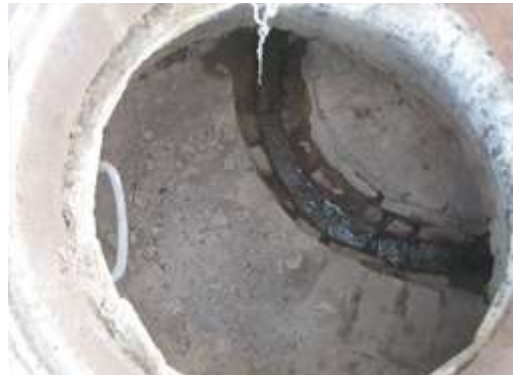
Top View

Facing west

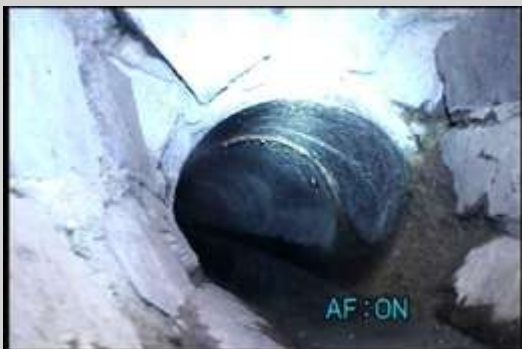
3 O'Clock Inflow

6 in. Circular Gravity Sewer
Pipe In @ 3 O'Clock

Pipe Height: **6** (in.) Rod and Bar (Angled)

Pipe Material: **Clay** ☐ Pipe Lined

Infiltration: **None** Pipe Seal Cond: **Sound**
